DEPARTMENT OF TRANSPORTATION

Contract #: 04-0120F4Cty: SF/ALA Rte: 80 PM: 13.2/13.9File #: 99.28**WELDING INSPECTION REPORT****Resident Engineer:** Siegenthaler, Peter**Address:** 333 Burma Road**City:** Oakland, CA 94607**Report No:** WIR-017770**Date Inspected:** 05-Nov-2010**Project Name:** SAS Superstructure**OSM Arrival Time:** 700**Prime Contractor:** American Bridge/Fluor Enterprises, a JV**OSM Departure Time:** 1900**Contractor:** Zhenhua Port Machinery Company, Ltd (ZPMC) Chanxing Island**Location:** Shanghai, China**CWI Name:** Mr. Xu Tao**CWI Present:** Yes No**Inspected CWI report:** Yes No N/A**Rod Oven in Use:** Yes No N/A**Electrode to specification:** Yes No N/A**Weld Procedures Followed:** Yes No N/A**Qualified Welders:** Yes No N/A**Verified Joint Fit-up:** Yes No N/A**Approved Drawings:** Yes No N/A**Approved WPS:** Yes No N/A**Delayed / Cancelled:** Yes No N/A**Bridge No:** 34-0006**Component:** OBG Segment and Bike Path**Summary of Items Observed:**

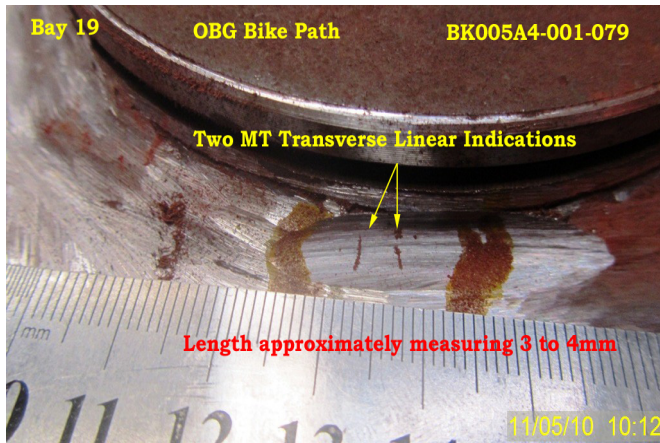
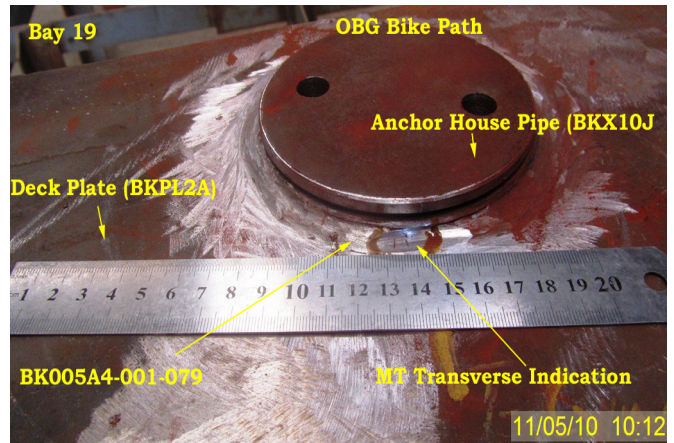
Bay 19

Description of Incident: During random Quality Assurance Magnetic Particle Testing (MT) verification of welds located on OBG Bike path, Caltrans (CT) Quality Assurance Inspector (QA) discovered that two (2) Transverse Linear Indications measuring approximately 3 to 4mm in length. The indications were found on bike path BK005A-001 and weld number is identified as BK005A4-001-079. This weld is a Fillet Weld joining the Anchor House Pipe (BKX10J) to Deck Plate (BKPL2A). The Anchor House Pipe to Deck Plate is identified as Non SPCM. The indications are clearly marked on the material near the weld. OBG Bike Path BK005A-001 is located in bay#19. For further information, please see the attached pictures.
